Reducing Radon in Child Care Centers

~Case Studies~

Cody Wright
Synergy Home Inspections
C-NRPP # 201559/201560

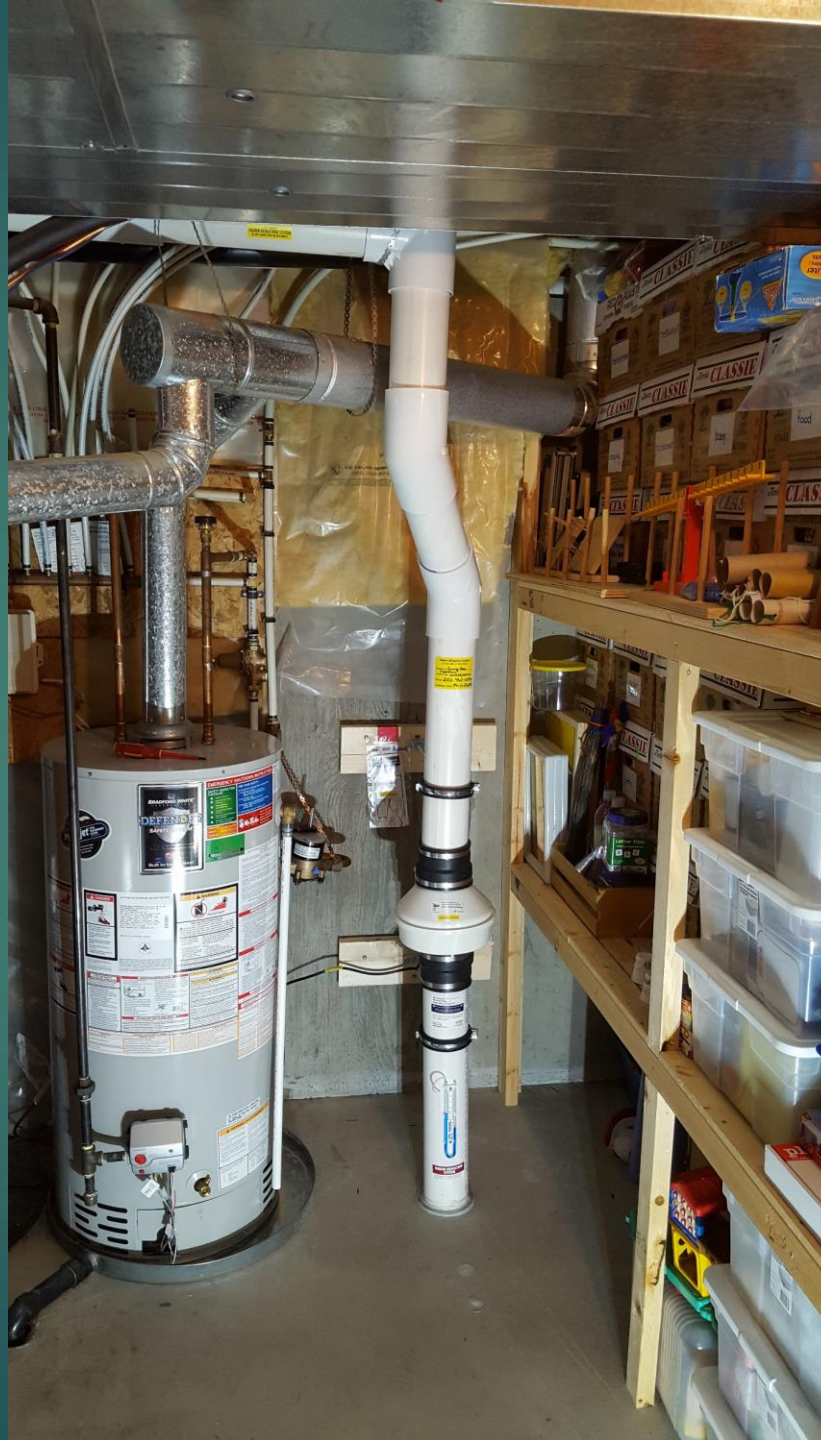
- ▶ Installed in Furnace room
- ▶ Side wall discharge
- ▶ Challenges: Furnace room in center of finished basement. Rim joist located just above grade height; tricky discharge route.

Before: Over 1000 Bq/m³

After: 16 Bq/m³

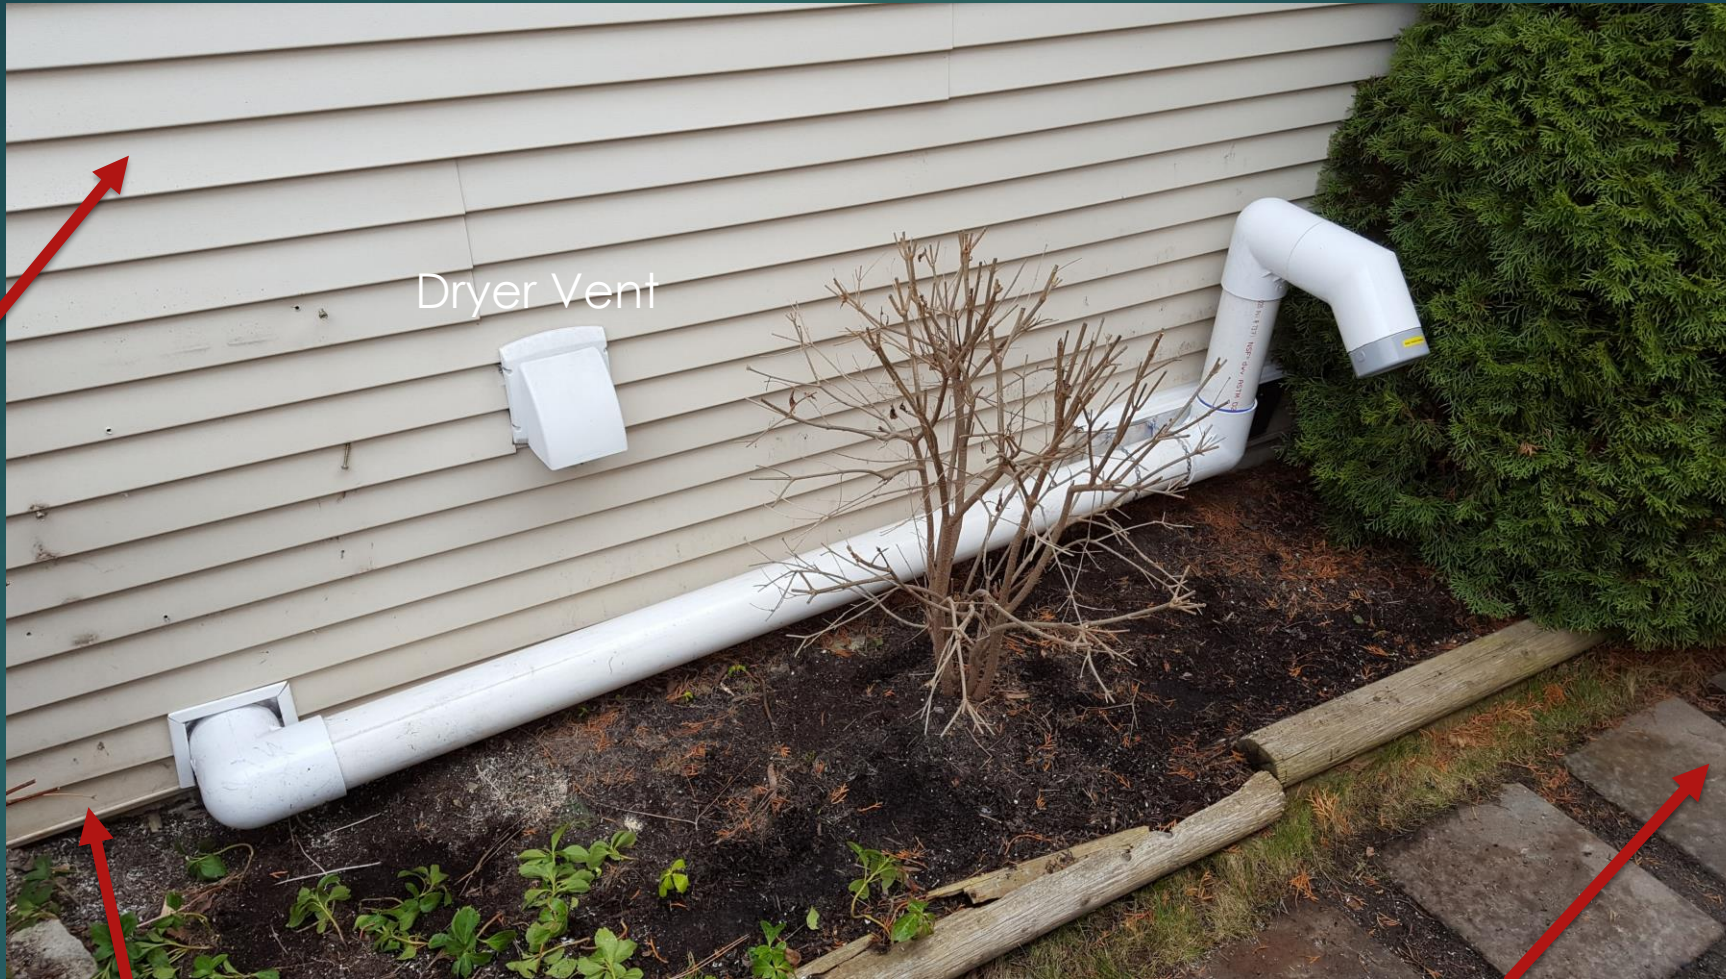
Difficult Termination Location

Window

Dryer Vent

Exterior Door

Rim joist at grade height

Walkway to access daycare

Note: Long pipe runs are not recommended in unconditioned spaces, unless required, due to potential for ice build up. Monitor these types of systems for ice build up during winter months, and ideally, insulate the exposed pipe, if the client is in agreement.

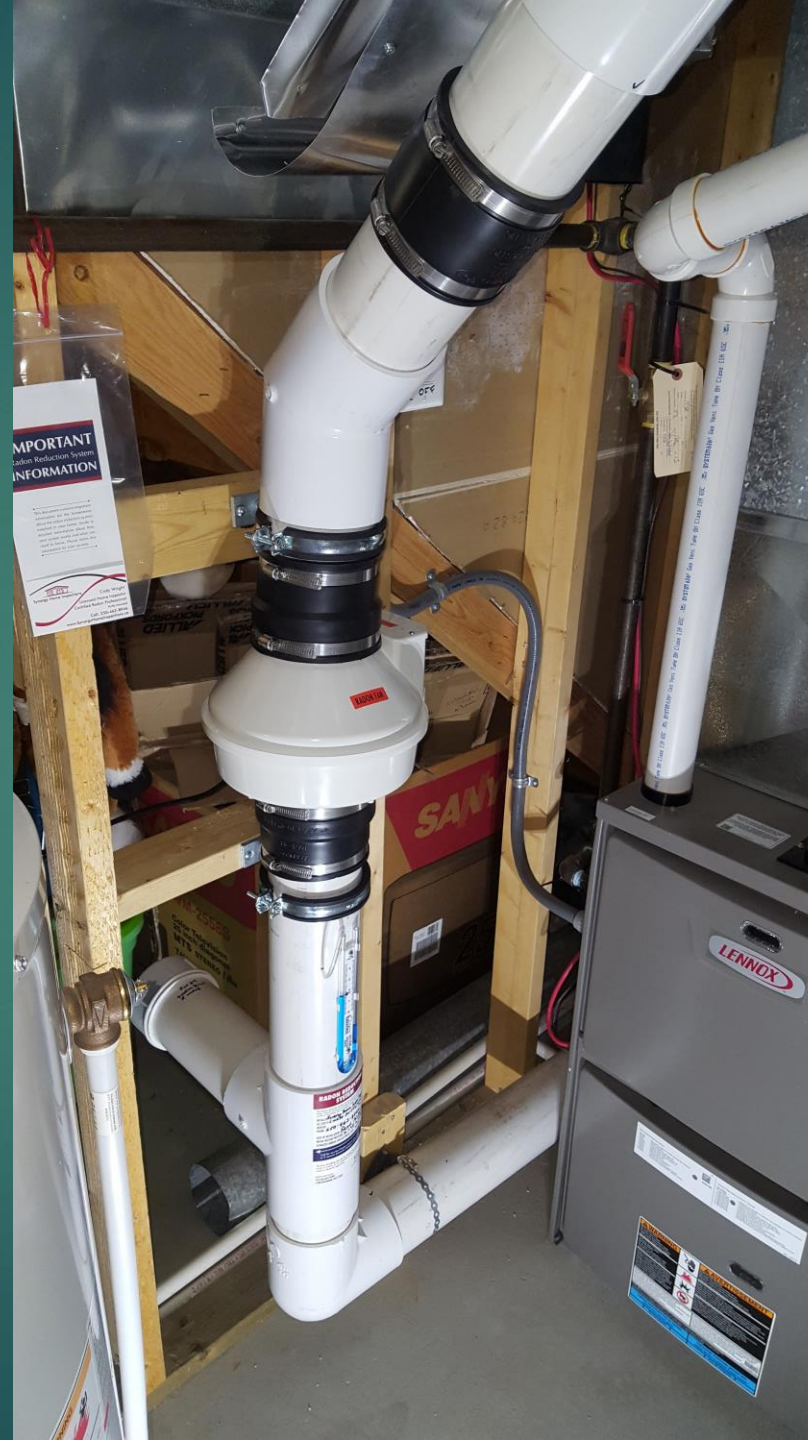
- ▶ Installed in Furnace room
- ▶ Side wall discharge
- ▶ Challenges: Finished basement. Viable suction points located next to furnace; small area to work. Large amounts of stored items. Cost effective termination point was to be located adjacent to walkway accessing daycare; however, it is a high traffic area. **Client did not want to spend additional money to locate termination point further away.**

Before: Over 350 Bq/m³

After: 28 Bq/m³

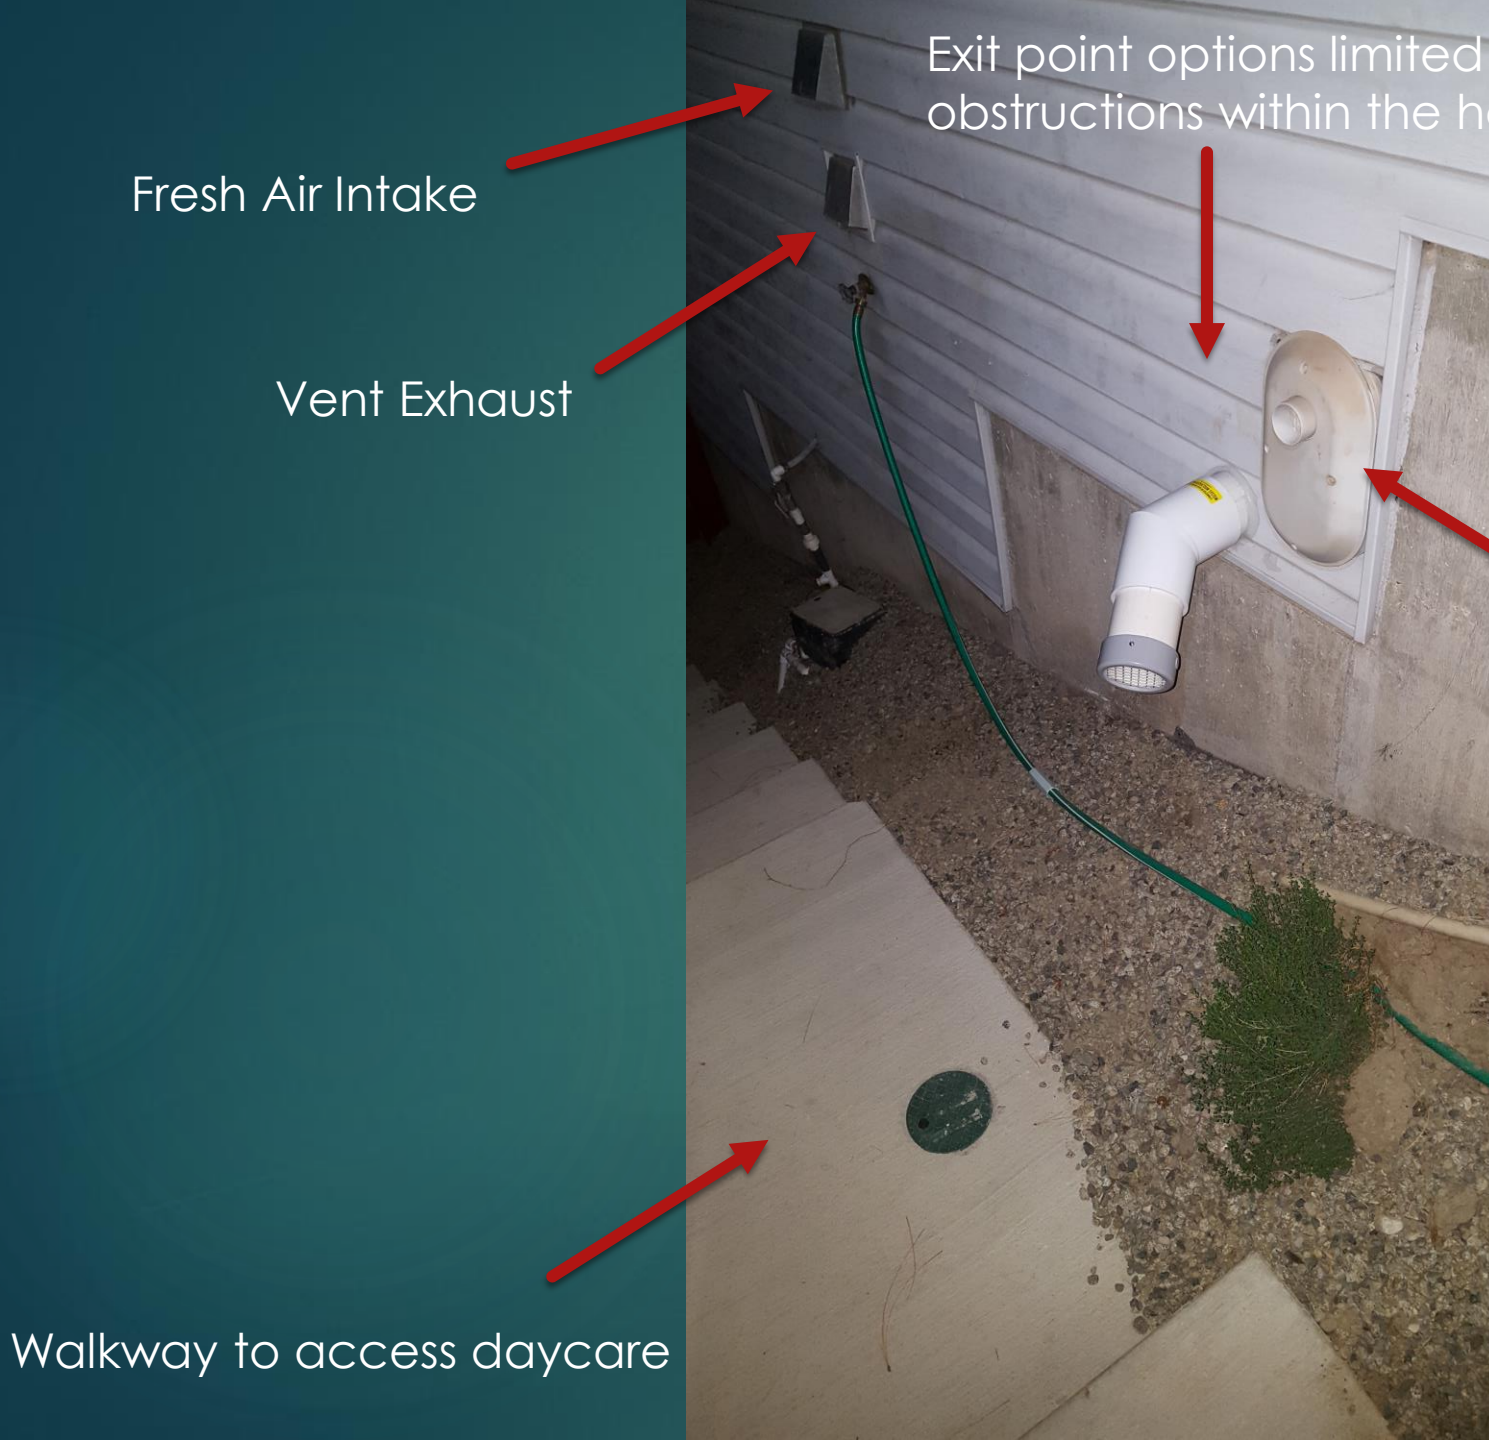
Difficult Termination Location

Exit point options limited by utility obstructions within the home

Fresh Air Intake

Vent Exhaust

Walkway to access daycare

Direct Vent Sealed Combustion Gas Furnace Vent

Note: Client did not want to spend additional money to locate termination point further away

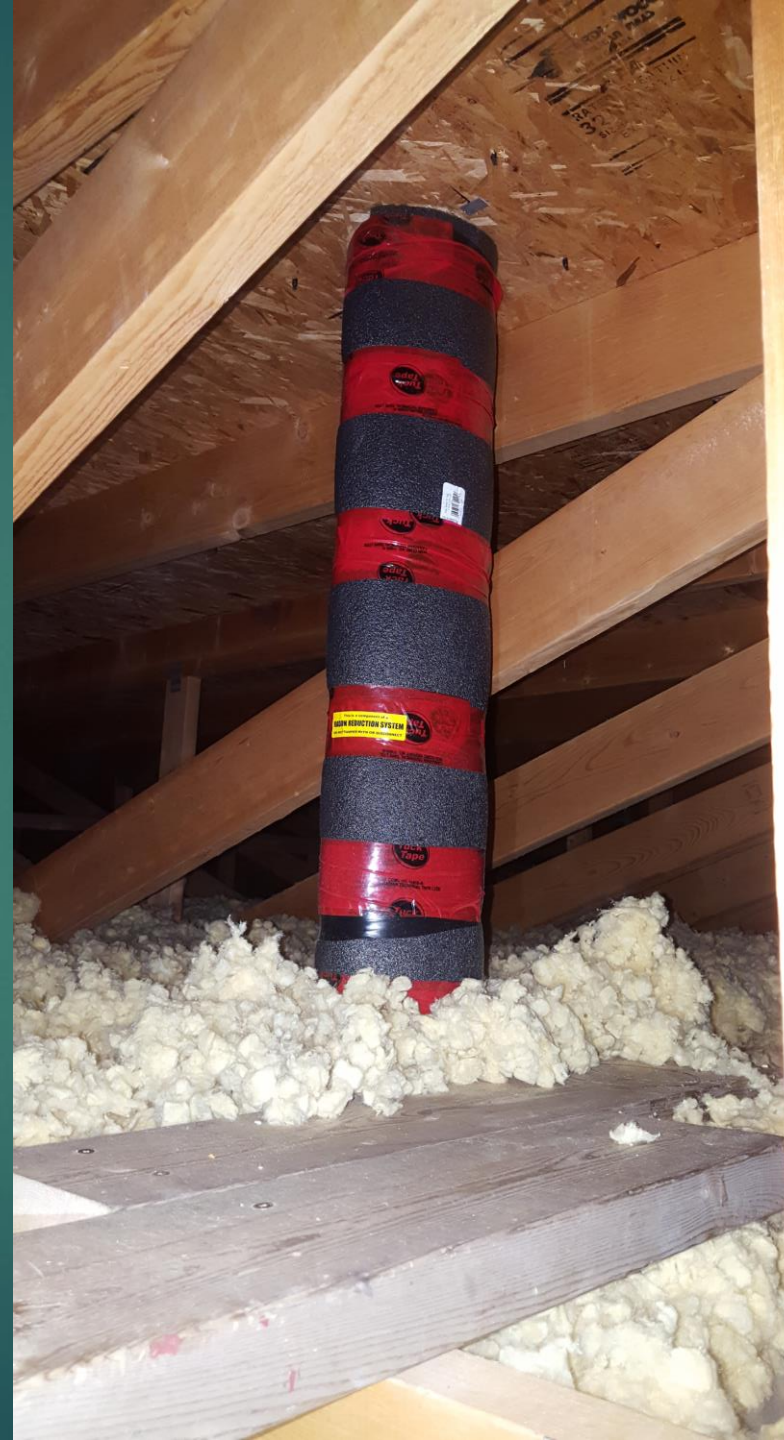
Inside
attic

- ▶ **Other contractors can create more issues and work for the contractor.**
E.g. A Roofer only used a 2 inch hole saw to drill through the roof deck, but installed a 5 inch stack flashing. The contractor was required to enlarge hole from inside attic. (Caution: Potential for cutting or puncturing roof membrane from below.)
