Reducing Radon in Child Care Centers

~Case Studies~

Cody Wright
Synergy Home Inspections
C-NRPP # 201559/201560

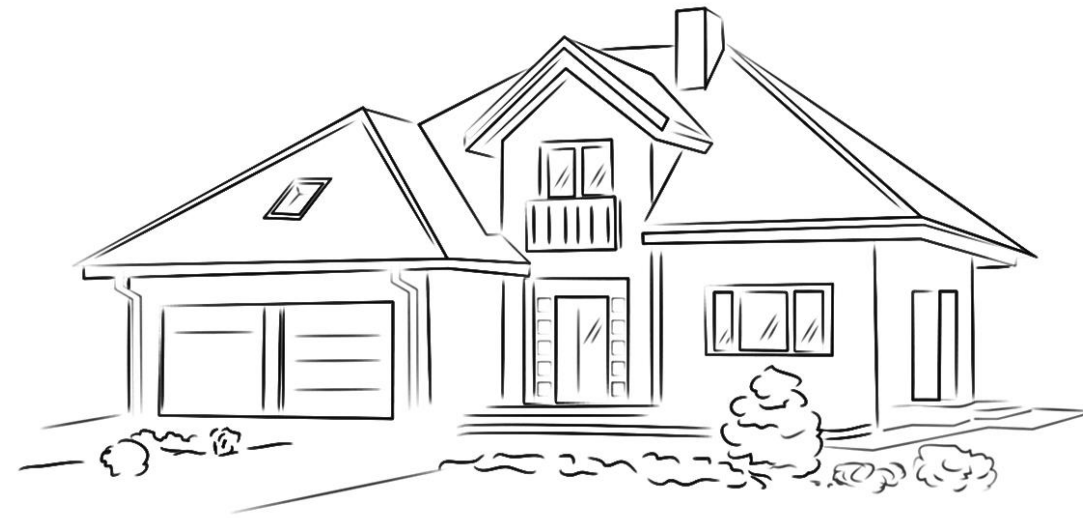
- ▶ Tested above 1,000 Bq/m³;
- ▶ Residential structure;
- ▶ owned by owner/operator
- ▶ Family lived upstairs with child care center in the basement

- ▶ 2 storey home with basement
- ▶ ~2500 sq ft
- ▶ Built in 2000
- ▶ Vinyl siding, finished basement
- ▶ Fenced backyard
- ▶ Well maintained home

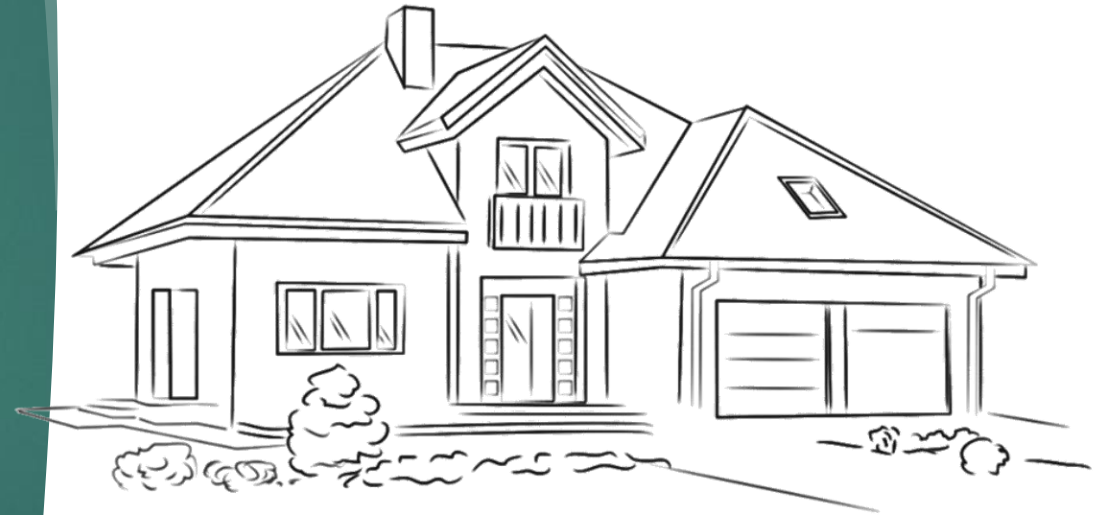
- ▶ Tested above 350 Bq/m³;
- ▶ Residential structure;
- ▶ owned by owner/operator
- ▶ Family lived upstairs with child care center in the basement

- ▶ 2 storey home with basement
- ▶ ~2500 sq ft
- ▶ Built in 1991
- ▶ Vinyl siding, finished basement
- ▶ Fenced backyard
- ▶ Well maintained home

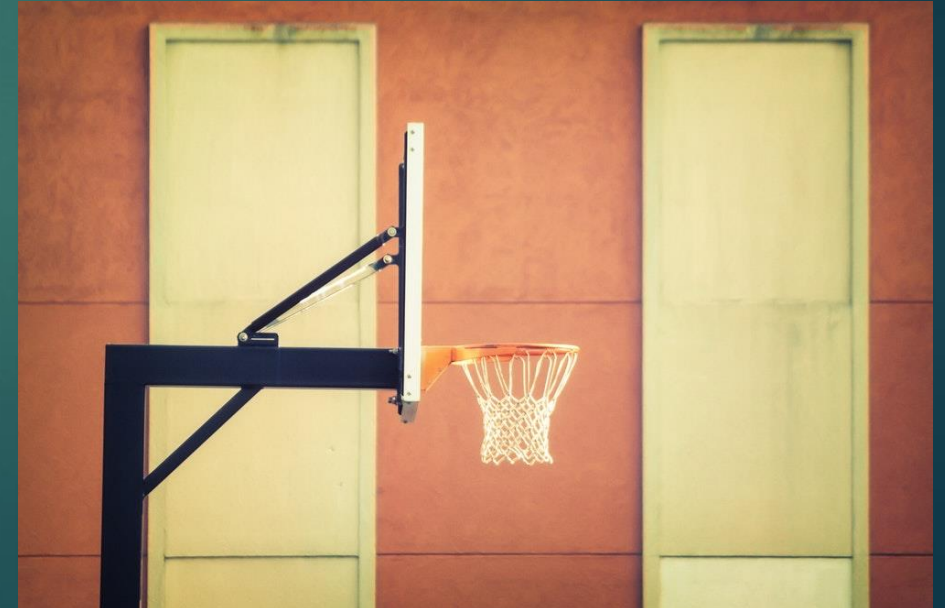
- ▶ Estimated 15-20,000 Sq ft
- ▶ Community Center with offices staffed daily
- ▶ Gymnasium, kitchen, stage, workout area
- ▶ Different programs are run
- ▶ 3 Long Term Tests performed simultaneously between Feb 2017 and May 2017
 - ▶ High of **451 Bq/m³**
 - ▶ Job bidding started Summer 2018
 - ▶ Mitigation conducted Winter 2018

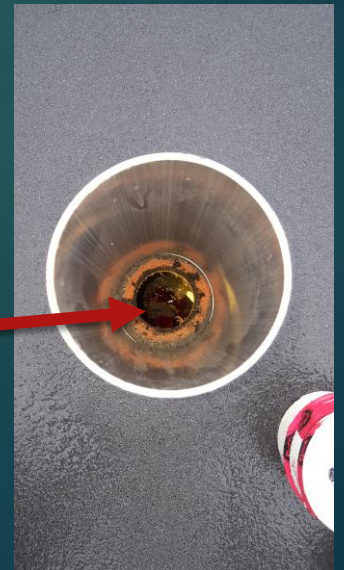
- ▶ Flat roof with torch on roof membrane
 - ▶ required roofing contractor to open membrane and install stack flashing
 - ▶ = extra cost \$\$\$
 - ▶ Do not touch a roof unless it is verified that it is no longer under warranty, otherwise a contractor could be at fault for defects or damages relating to the roof and mitigation install

- ▶ **Other contractors can create more issues and work for the contractor.**
E.g. A Roofer only used a 2 inch hole saw to drill through the roof deck, but installed a 5 inch stack flashing. The contractor was required to enlarge hole from inside attic. (Caution: Potential for cutting or puncturing roof membrane from below.)
